Status of the BRAMS network and recent progress

H. Lamy & BRAMS team

BRAMS network : full inspection during summer / fall 2018

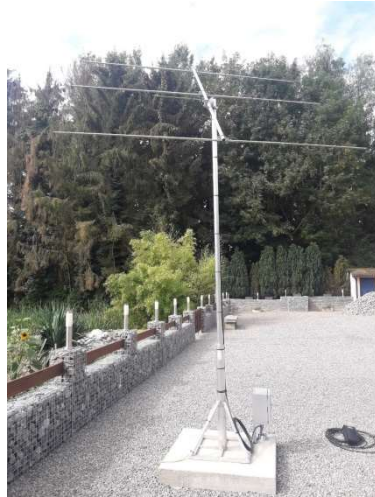
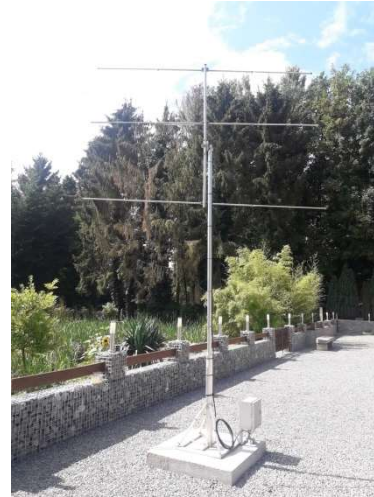
BELEUZ

Receiving stations : vertical orientation

Radiation pattern
much more closer
to theoretical one

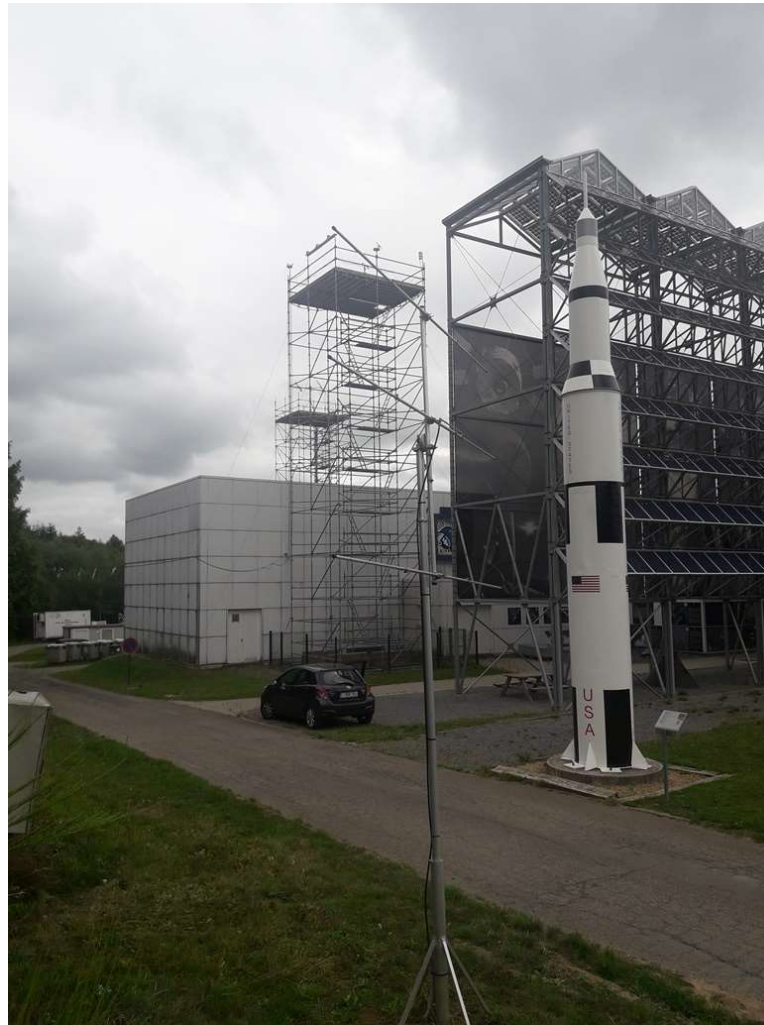
BEREDU

Receiving stations : change of azimuth orientation

Goal : trying to minimize local interference

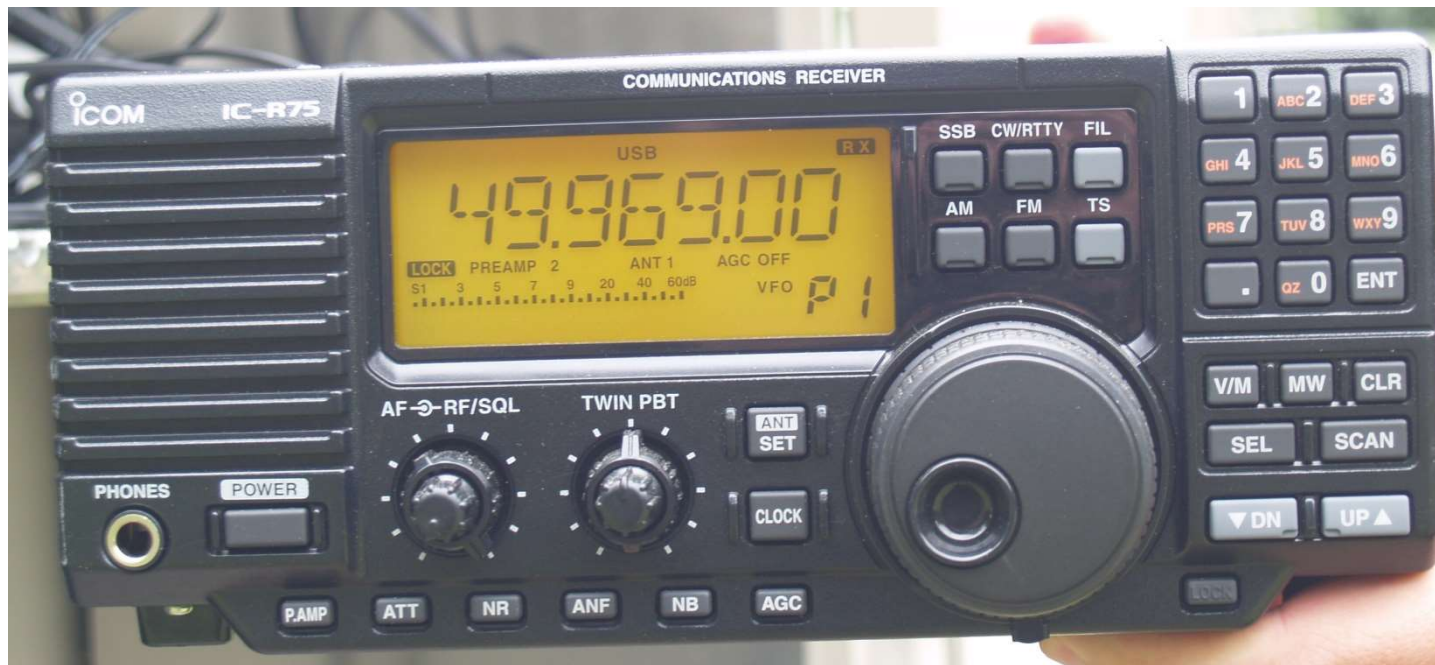
ICOM-R75 receivers

- At least 15 of them had problems with a progressive loss of sensitivity.
- The origin of the problem was identified by M. Anciaux who was able to repair them
- ICOM-R75 are not commercially produce anymore → search for new solutions using SDR receivers (see talk by Michel)

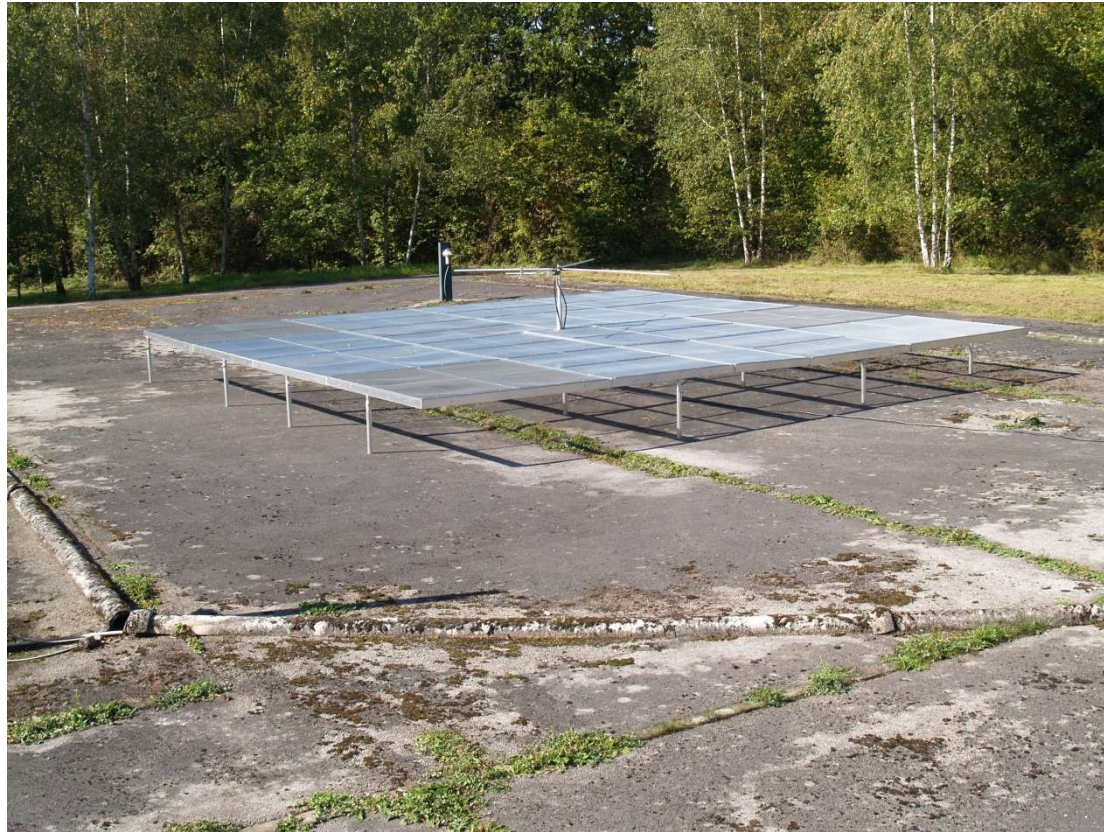
Transmitter in Dourbes

$P \sim 150 \text{ W}$
Circular polarisation
 $f = 49.97 \text{ MHz}$

Is this correct? → full characterization on 21 September

- Full characterization of the Tx on 21/09/2018 using dummy load, wattmeter, oscilloscope and antenna analyzer
- Power amplifier characterization : using the Wattmeter in between the amplifier and the antenna, we found $P_{\text{forward}} \sim 110 \text{ W}$ and $P_{\text{reflected}} \sim 15 \text{ W}$, providing a $\text{SWR} \sim 2.2$. Total power at the antenna should then be of the order of 95 W. More accurate measurements using the dummy load and the oscilloscope give $P_{\text{forward}} = 104.7 \text{ W}$ incident on the antenna cable.

- Antenna characterization : Two 50Ω cables in parallel linked by a T \rightarrow equivalent resistance (resistive part) measured at the extremity of the RF cable is $\sim 25.6 \Omega$ as expected. Taking into account the losses in the cable, we expect an incident power of 95.5 W at the entrance of the T

- Independent measurements of the adaptation of the two individual antennas: $\text{SWR}=1.68$ and 1.16
- Ant 1 : $P=44.3 \text{ W}$ – Ant 2 : $P=40.6 \text{ W}$, $\theta = -96^\circ$

- Conclusions :
 - We emit far less than 150 Watts (~ 90 Watts)
 - The emitted wave is not perfectly circularly polarized but not too far (96° instead of 90°)
- Still to do :
 - Measurements of the radiation pattern in-situ using our drone (January?)
 - Replacement of the current system with an improved design to guarantee 150 W emission and perfectly circularly polarized wave

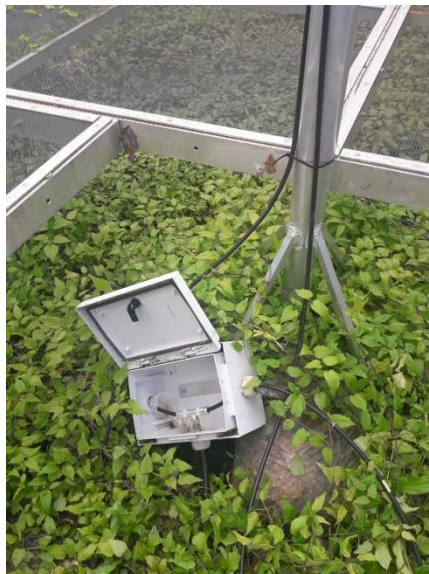
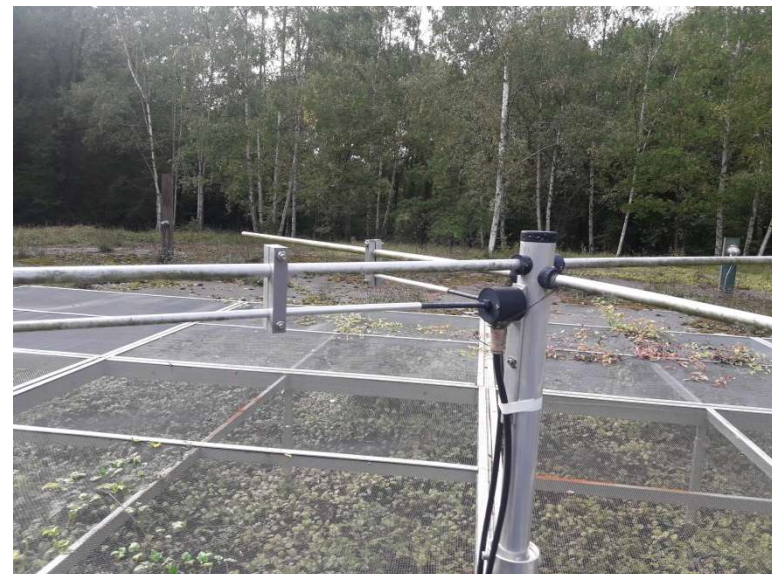
Ecoflex 15 RF cable

Transmitter in Dourbes

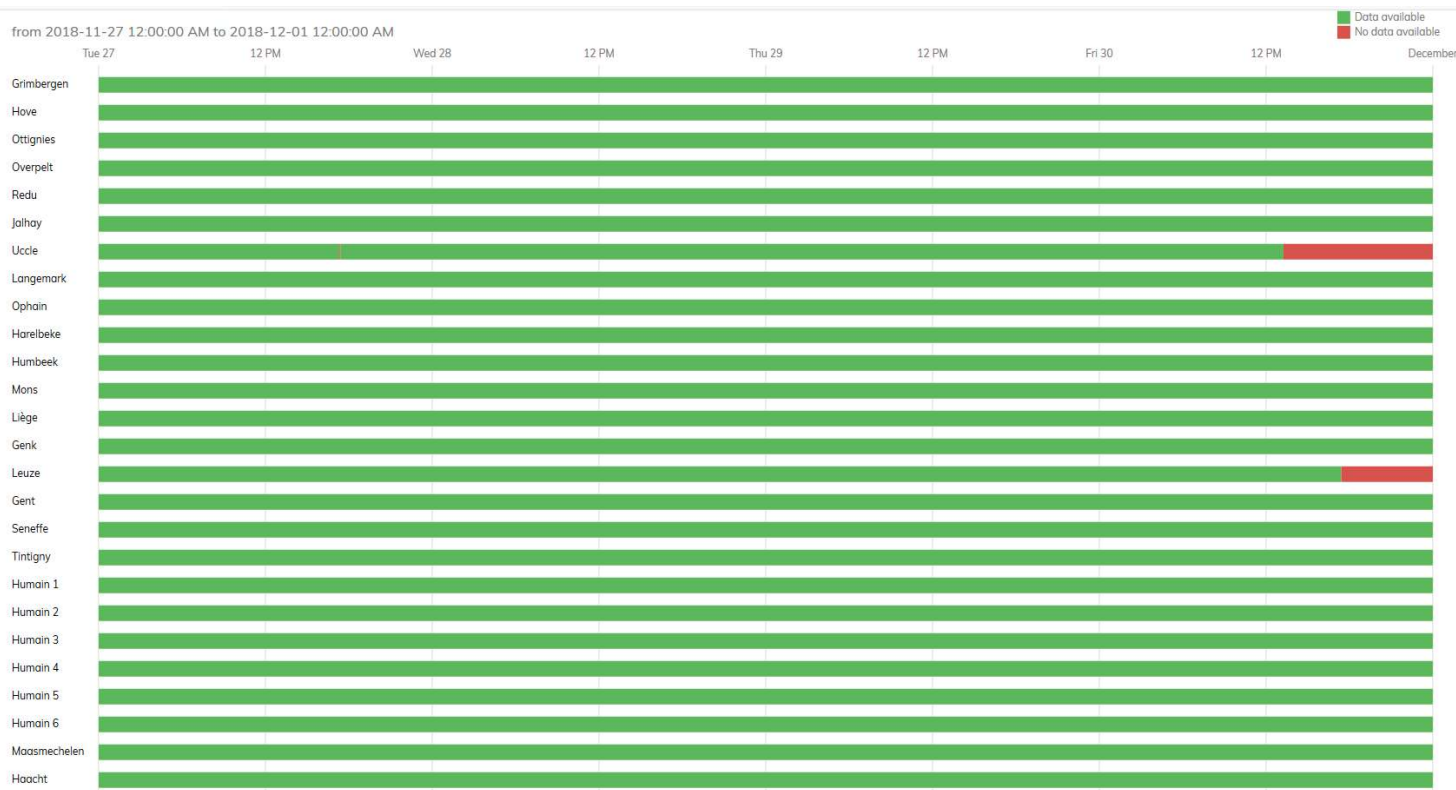
BRAMS
availability
tool

- Data from all 26 stations are now transferred via FTP
- 23 stations are automatically transferring the data daily using the BRAMS-FTP facility
- 3 stations are sending their data weekly using FileZilla
- 17 stations can be accessed remotely via Team Viewer or Remote Desktop.

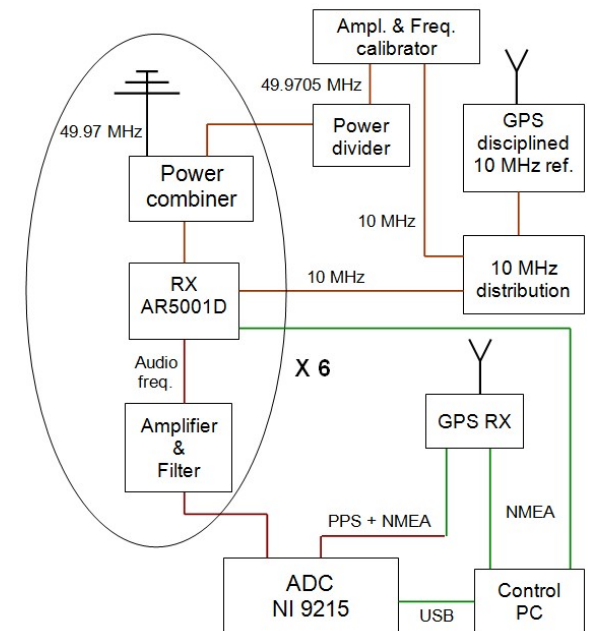
Works well in Humain
